# Technical problems and non destructive testing of rock bolt support systems in mines

The problem of proper assessment of the technical functionality of rock bolt support systems is still valid. Many research centers have undertaken efforts to diagnose and monitor the technical state of such a support system used in mines and tunneling. With that aim the method of quality assessment of grouted rock bolts was invented and a relevant apparatus was constructed. The method concerns non-destructive identification of discontinuity of a resin layer (grout) surrounding rock bolts. The method is based on an impact excitation of a rock bolt and uses modal analysis procedures. Assuming that the installed rock bolt acts as an oscillator, different lengths and positions of grouting discontinuity alter its modal parameters. The extraction of these modal parameters, of which a resonant frequency is seen as the most valued, enable the relevant identification of grout discontinuity. After constructing a prototype version and validating the results for known cases of resin discontinuity in an experimental coal mine, the apparatus fulfilling ATEX requirements was developed. Subsequently that versio

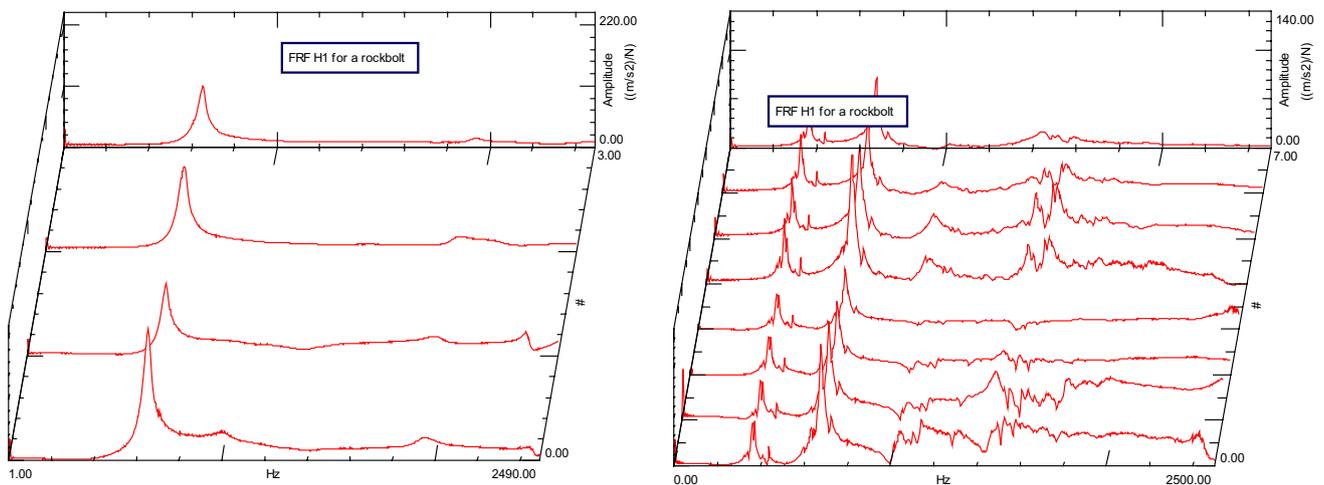
Fig. 3 An examples of the recorded FRF functions for proper (left) and improper (right) grouting

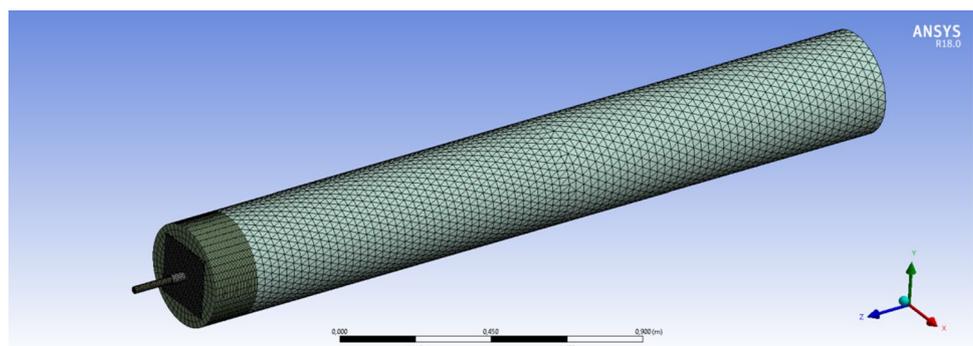
**Fig. 4** An example of a finite element model for an analyzed case study

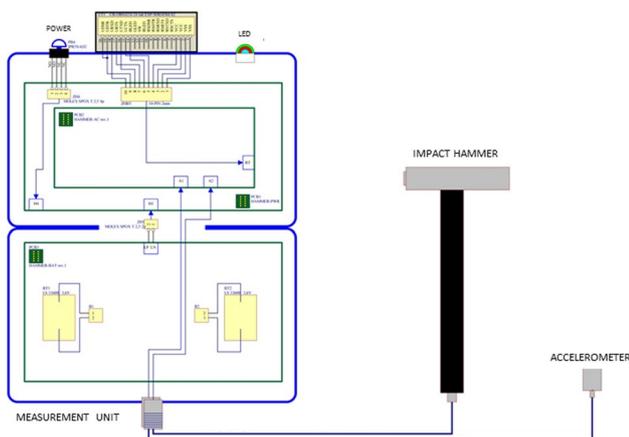
**Fig. 5** The block diagram of the final version of portable measurement system fulfilling ATEX requirements

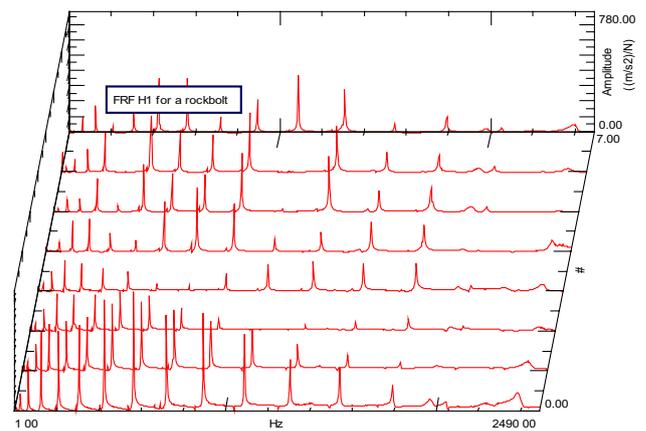
**Fig. 6** The FRF functions (waterfall curve) for a diagnosed rock bolt in laboratory conditions

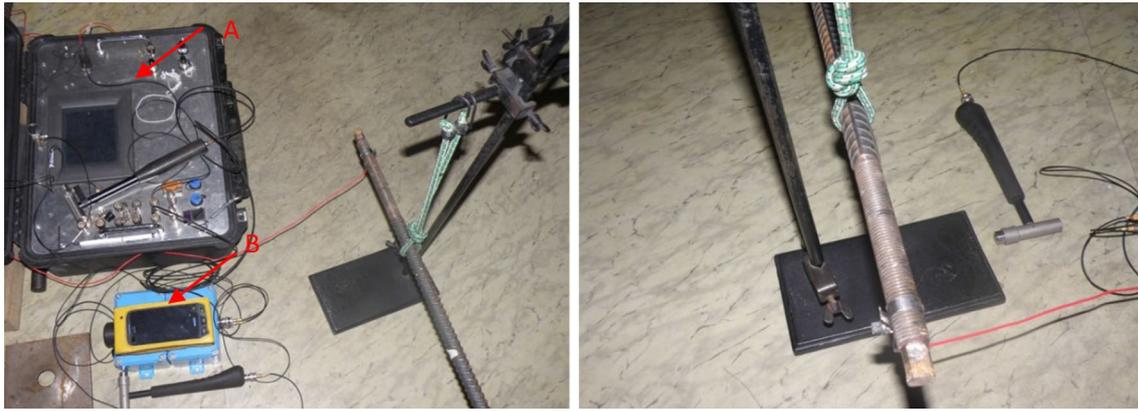
**Fig. 7** The validation of the portable measurement system for quality control of installed rock bolts, A—working prototype versus B—final version fulfilling ATEX requirements

demanded for measurements in explosive atmospheres, a measurement apparatus has to fulfill ATEX directives (two EU directives describing the minimum safety requirements of the workplace and equipment used in explosive atmosphere). With that aim a new construction was designed and developed. The block diagram is shown in Fig. 5. Then a validation of the new measurement unit with the prototype version (assembled with National Instruments components) was realized. The comparison was performed in laboratory conditions and in an experimental coal mine. In laboratory a freely supported rock bolt was diagnosed. The measured frequency response functions (FRF) are shown in Fig. 6 and the measurement stand up presented in Fig. 7. The obtained

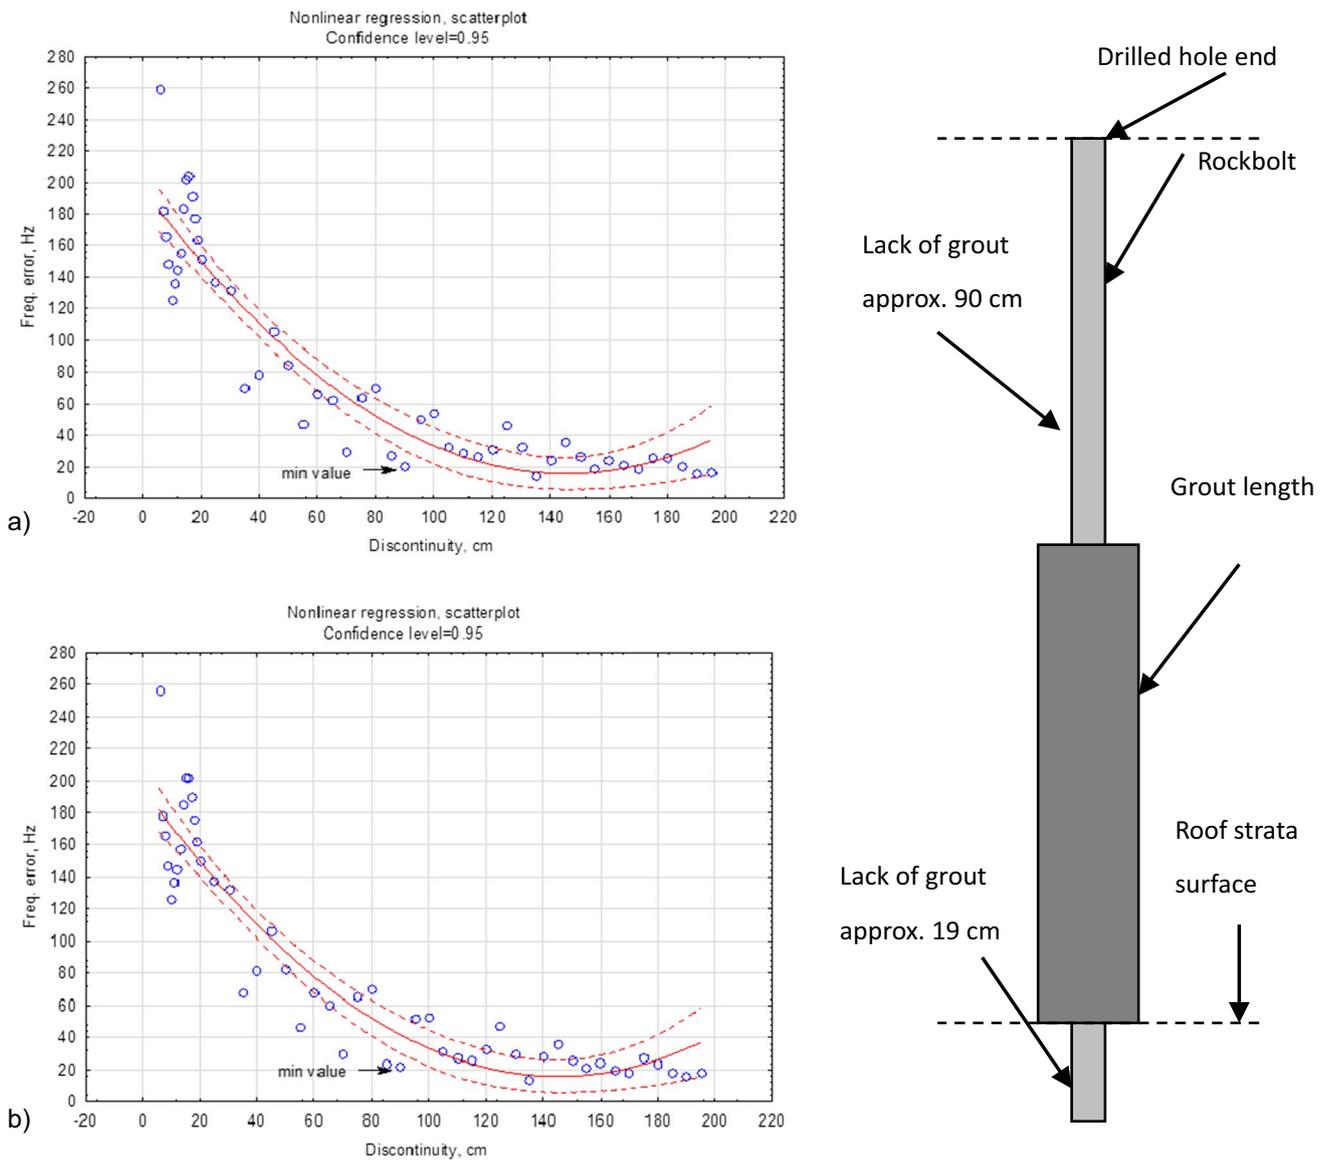
**Fig. 8** Scatter plot of the differences between FE model and data evaluated experimentally (here for hidden, inner part only). The value of the length of discontinuity is specified for the first minimum differences of models (experimental and theoretical). **a** For measurements

with the working prototype, the lower one **b** For measurements with the final version of the measurement unit. The discontinuity lengths are: 90 cm (inner part) and 19 cm (outer part, scatter plot not shown here)

measurement setup) was quite satisfactory. In Fig. 8 the scatter plot of the differences between FE model and data evaluated experimentally is shown (here only for the inner, hidden part of the rock bolt). The values of the lengths of discontinuity are 19 cm and 90 cm and they were also consistent for both measurement units.

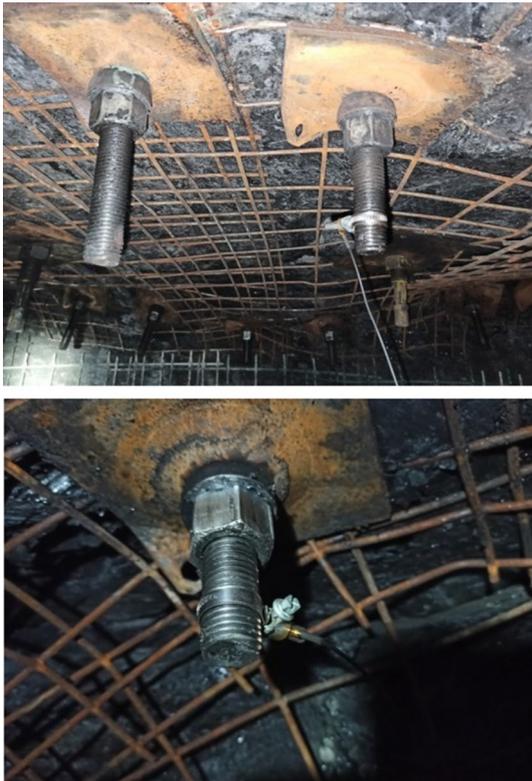
**Fig. 9** The investigated rock bolts in an underground opening in a working coal mine

such a value was used in the finite element models (FE). It is not a constraint and other torsion forces may be used depending on real conditions; a thorough discussion on that topic is accessible in technical literature (Hyett et al. 2012; Cała et al. 2001). The measurements were performed periodically during about two years’ and around 70 rock bolts were tested. In Fig. 9 examples of such sessions are presented.

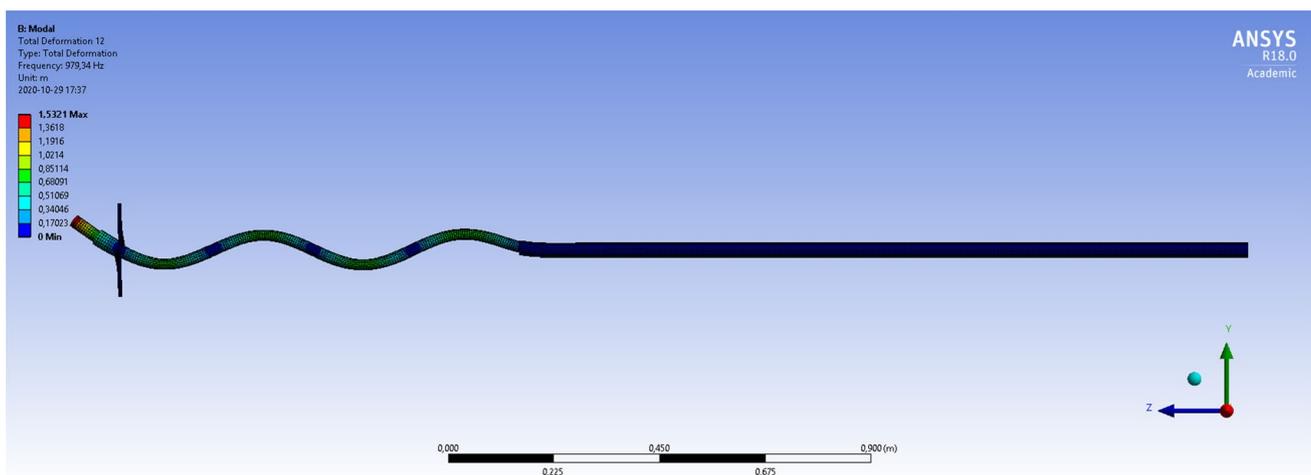
**Fig. 10** The example of diagnosed rock bolts with lack of grout approximately equal to 0.80 m from the roof strata surface (rock strata elements not shown) with one of the modes of 979.3 Hz

In the first particular area several cases were diagnosed with lack of grout approximately equaled to 0.8 m from the roof strata surface. The example of the theoretical model (rock strata elements are hidden) referring to such a case is shown in Fig. 10.

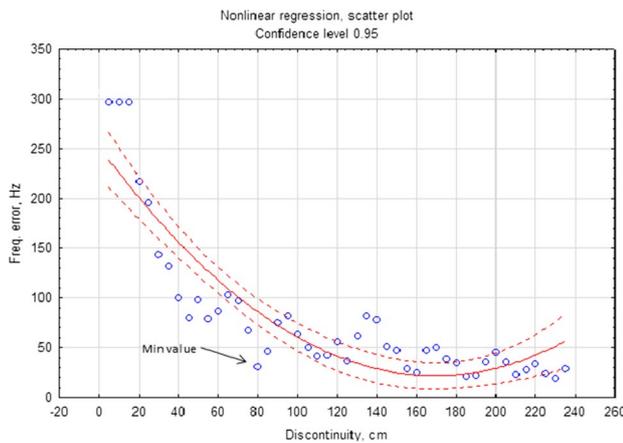
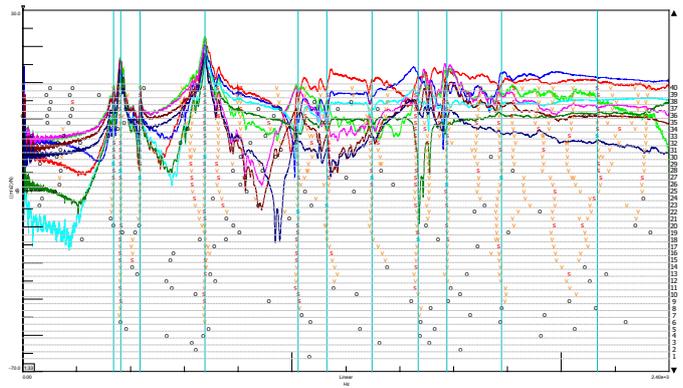
**Fig. 11** The results of estimation of the grout length: the characteristics of the transfer function for the analyzed case, the vertical axis of the chart—inertance, in (m/s<sup>2</sup>)/N, the horizontal axis—frequency, in

Hz and the scatter plot of the differences between FE model and data evaluated experimentally (min value for 0.80 m)

characteristics of the transfer function for one of these analyzed cases and the scatter plot of the differences between FE model and data evaluated experimentally are presented in Fig. 11.

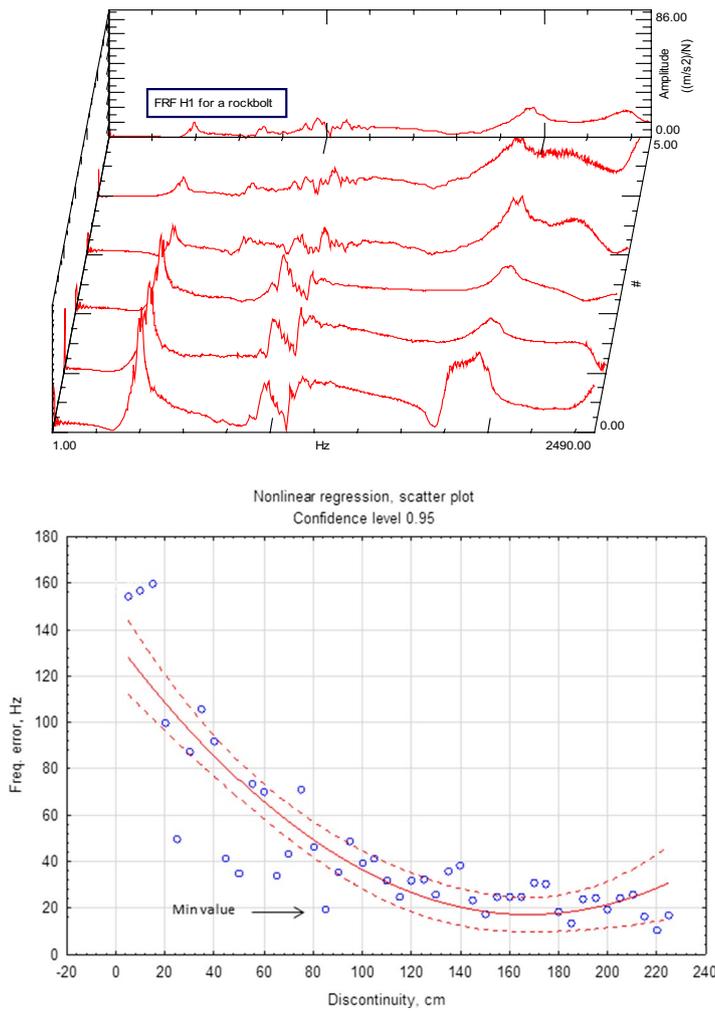
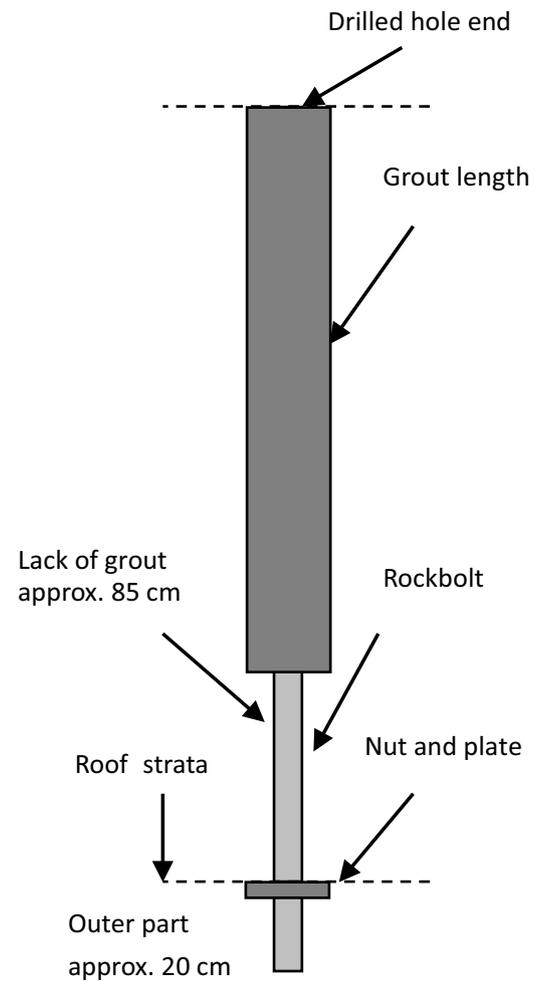
**Fig. 12** The results of estimation of the grout length: the characteristics of the transfer function for the analyzed case (waterfall chart for points of excitation), the vertical axis of the chart—inertance, in (m/s<sup>2</sup>)/N, the horizontal axis—frequency, in Hz and the scatter plot of the differences between FE model and data evaluated experimentally. The geometry of lack of grout is also presented

The identified natural frequencies of the investigated rock bolt are presented in Table 5. The results of estimation of the grout length: the characteristics of the transfer function for the analyzed case, the estimated grout length (the length of the rock bolt is equal to 2.5 m) and the scatter plot of the differences between FE model and data evaluated experimentally (min value for 0.85 m, outside the random scatter) are shown in Fig. 12.

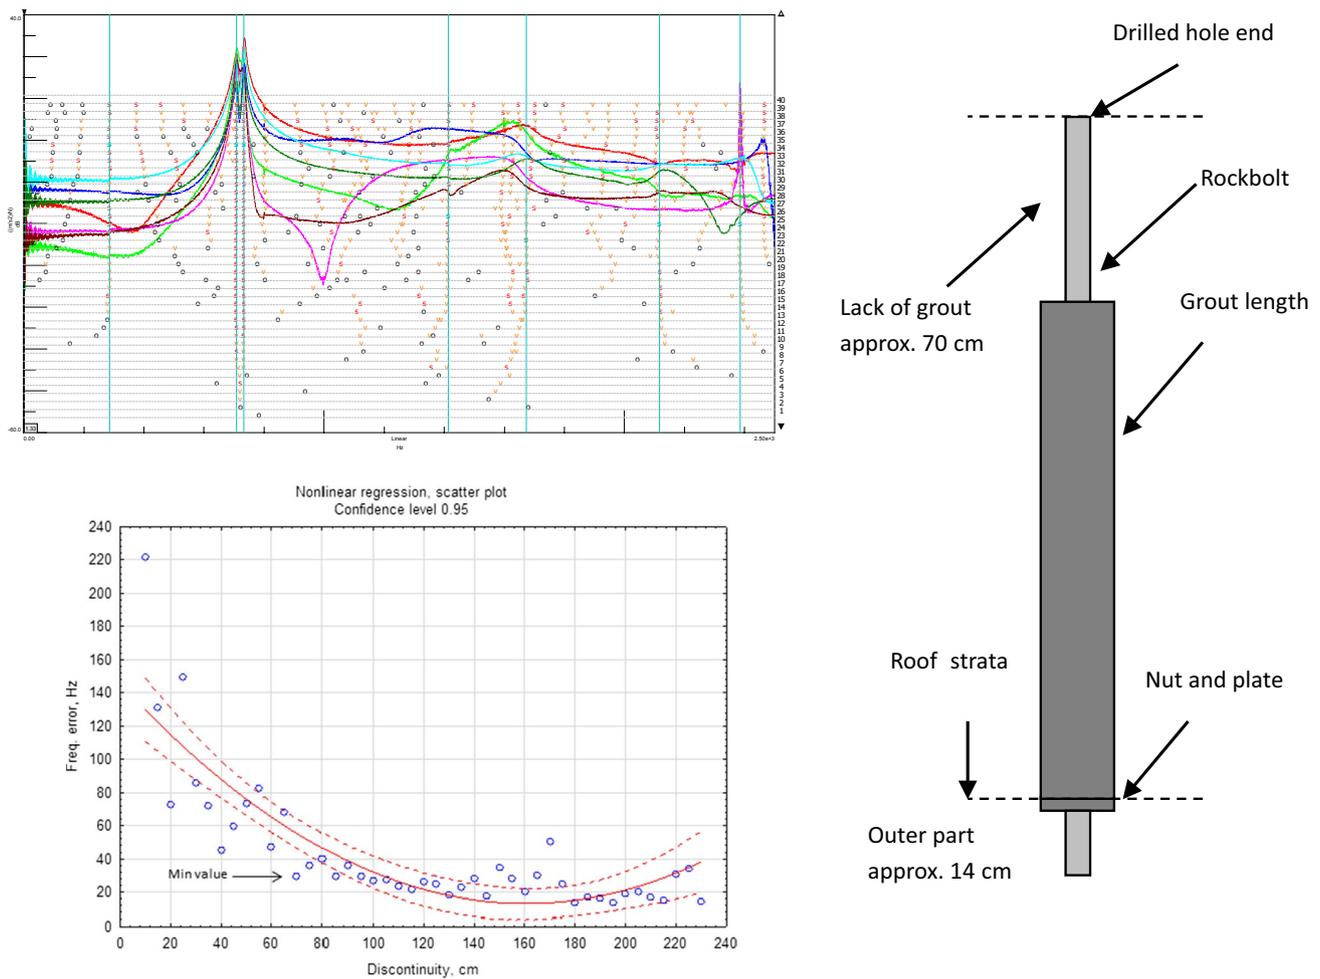
**Fig. 13** The results of estimation of the grout length: the characteristics of the transfer function for the analyzed case, the vertical axis of the chart—inertance, in  $(m/s^2)/N$ , the horizontal axis—frequency,

in Hz and the scatter plot of the differences between FE model and data evaluated experimentally. The geometry of lack of grout is also presented

There were also sessions where other types of discontinuity were found, the example is described below. The identified natural frequencies of the investigated rock bolt are presented in Table 6. The results of estimation of the grout length: the characteristics of the transfer function for the analyzed case, the estimated grout length (the length of the rock bolt is equal to 2.5 m) and the scatter plot of the differences between FE model and data evaluated experimentally (min value for 0.70 m, outside the random scatter) are shown in Fig. 13.
